FOCUS ON FLANGE CORROSION PROTECTION

BELZONA 3411: PEELABLE MEMBRANE

BELZONA OFFERS ANTICORROSIVE AND PEELABLE PROTECTION FOR FLANGES IN BRAZIL

BELZONA 3411 SOLVES CORROSION ISSUE FOR A CHEMICAL PLANT IN USA

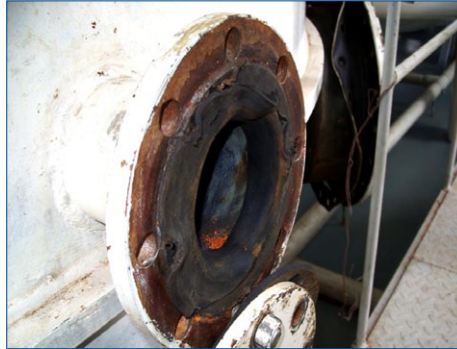
Exposure to corrosive environments or polluted industrial atmospheres can lead to high corrosion rates of unprotected flanges. Due to the complex geometry of a flanged connection, problems such as crevice corrosion are found within the gap between the two flange faces. Also, galvanic corrosion is commonly found where dissimilar metals are used and can cause severe damages to the integrity of the piping system.

Corrosion damages on flange

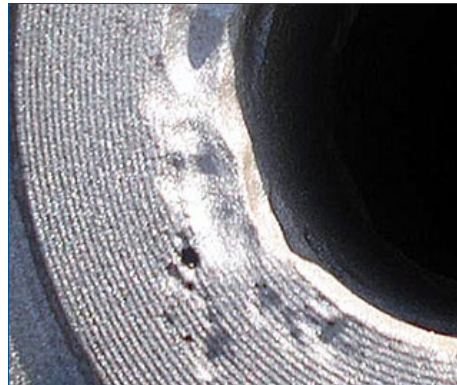
Crevice corrosion is a common damage mechanism where there is a concentration of corrosive substances in a localised area. Indeed, the rate of corrosion is accelerated by the concentration of corrosive materials within a confined space. The crevice between two flange faces is the ideal environment for crevice corrosion. The flange face is predominantly prone to crevice corrosion when flanges are used in extremely corrosive environments such as acid or sea water service.

Crevice corrosion on flange face

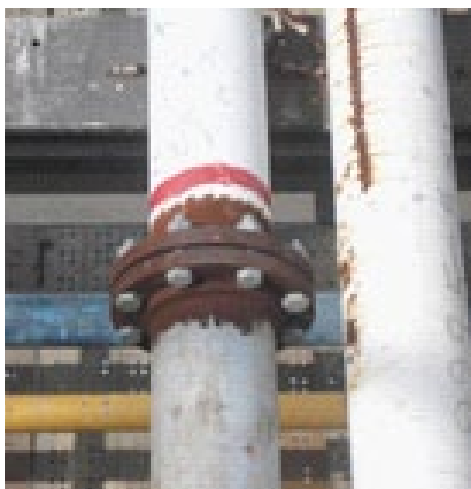
In January 2015, an independent tank storage provider in Bahia, Brazil, required corrosion protection for flanged joints connecting the pipework. The complex geometry of the flanged joints had caused a number of problems, such as crevice corrosion in the gap between the flange faces and galvanic corrosion, where the use of different metals can lead to serious consequences. In fact, on the 44 flanges recently installed on the site, several flanges had to be completely replaced due to severe corrosion. The flanges are found in a chemical storage company in a loading and unloading port and are therefore exposed to an aggressive and marine environment.

Corroded flange

The application was carried out in accordance with [Belzona Know-How System Leaflet GSS-11](#). All surfaces to which the Belzona system was to bond were cleaned with Belzona 9111 (Cleaner/Degreaser) to remove all dirt, grease and surface contaminants. The bond areas also required surface preparation to ensure good adhesion. The minimum level of surface preparation for the

system for exposed/corroded steel is wired brushing to ISO 8501-1 St 2/SSPC SP-2.

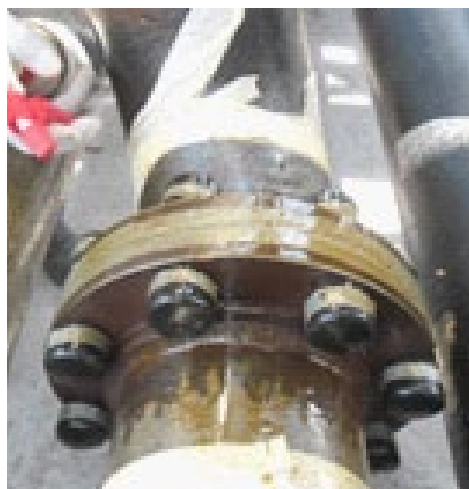
Application of Belzona 8411

The gap between flange faces was sealed with a strip of bond breaker tape, whilst masking tape was also applied over the two bond areas to protect these sections of pipe from accidental overspray of Belzona 8411, and hence impaired adhesion.

The system requires the use of Belzona 8411 to achieve the optimum level of corrosion protection and to allow access to bolts and flanges in the event of required maintenance. Belzona 8411 can be simply spray or brush applied onto the flange, pipe and fastenings ensuring the film coverage is even and complete.

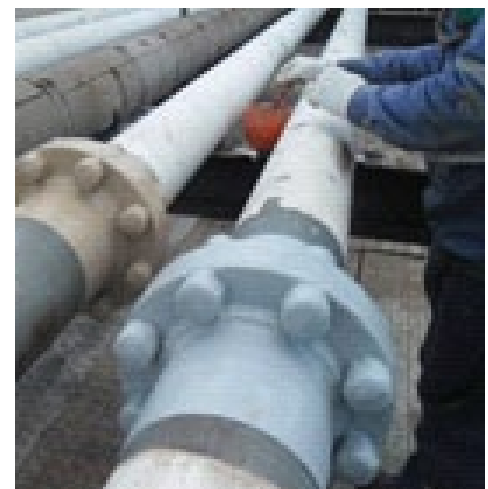
Application of Belzona 3411

Once Belzona 8411 was touch dry, the masking tape was removed and plastic caps fitted over the bolts. Belzona 3411 was applied in two coats, using strips of Belzona 9311 (Reinforcement Sheet) in the circumference and in the extremities of the flanges. Once the application had been completed, a visual inspection was carried out.

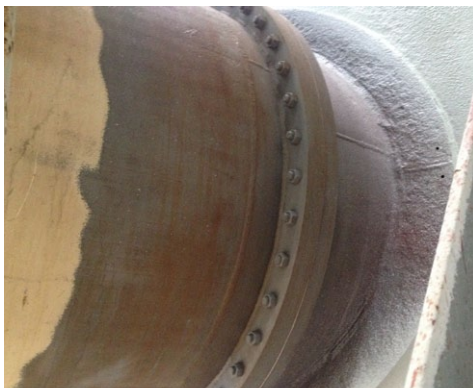
The customer had a 52" flange on a vessel connecting to outlet piping that needed corrosion protection. To avoid corrosion between the flange faces, a previous protection solution consisting of fiberglass coverings was used on other vessels in the unit. Fiberglass offers good corrosion resistance but these materials can however be time-consuming and expensive to apply. If access to bolts is required, fiberglass can be cut away, but is difficult to remove and normally must be replaced with a new system to reinstate the protection. In order to avoid these drawbacks, the client was looking for an alternative and more cost-effective protective solution

52" flange prepared for application

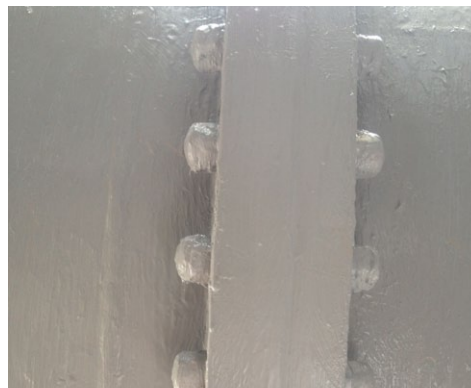
First coat of Belzona 3411

The application was carried out by the plant personnel in accordance with [Belzona Know-How System Leaflet GSS-11](#).

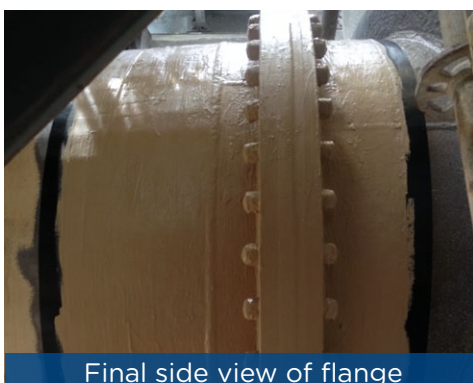
Final side view of flange

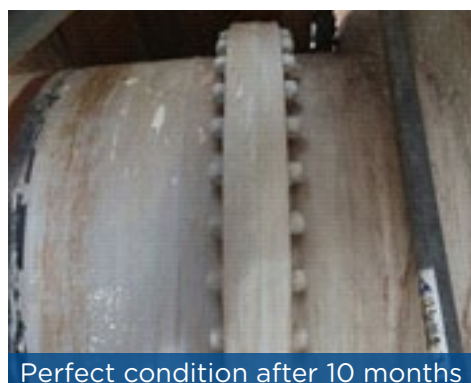
Perfect condition after 10 months

The customer saved several thousand dollars over the previous fiberglass system with easier installation. The unit was inspected 90 days after the installation and it looked as good as it did on day one. The application was revisited in April 2015 and the protection was still in perfect condition. The client was very satisfied with the Belzona solution and is planning to use Belzona 3411 on other flanges in the plant.

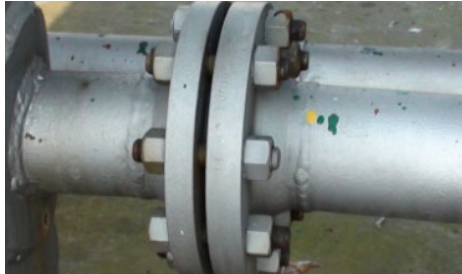
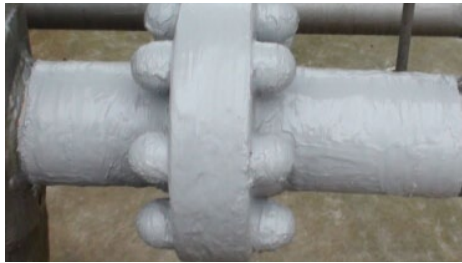
Belzona 3411 Solves Corrosion Problem for a Natural Gas Purification Plant in China

Flange on purification equipment

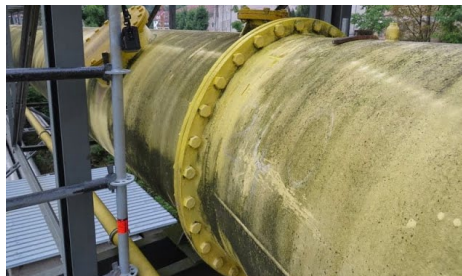
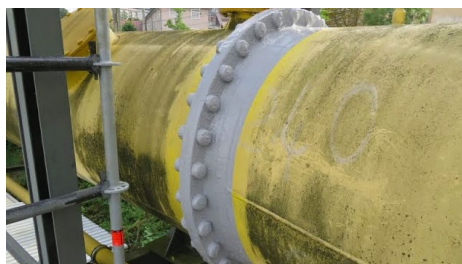
Belzona Solves Leaking Problem on Gas Pipe in Germany

Flange on natural gas pipe (diameter of the flange 1,30m)

Steel
